# THE ASSESSMENT AND REPAIR OF THE PRECAST RC STRUCTURE EXPOSED TO FIRE

*This paper presents the assessment and repair of precast RC structure exposed to fire in Novi Sad. Detailed visual inspection, which includes described and classified damages and defects of RC columns and beams, is presented in the paper. Control design of the built-in concrete and reinforcement, as well as geodetic survey and conclusion on the state of the structure, are carried out. Two possible repair solutions were analysed.*

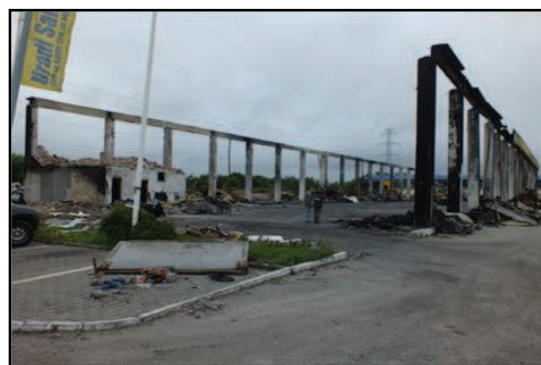
Figure 2: Object's appearance after fire and clearing the ground off

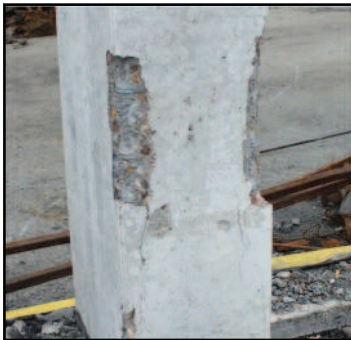
Figure 3: Cracking, separation and peeling of concrete along the column edges (up to the main longitudinal reinforcement), pronounced change in aggregate colour, net-like fissures

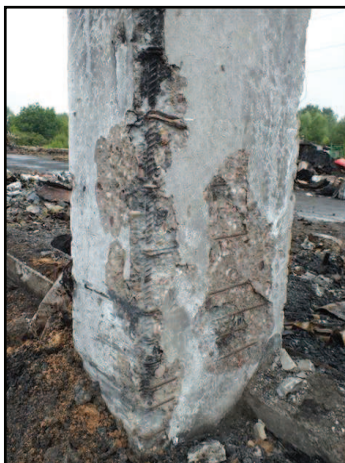
Figure 4: Peeling of crumbly protective layer of concrete, visible reinforcement

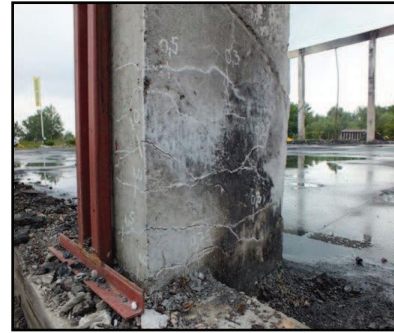
Figure 5: Horizontal cracks due to flexion of column (during the collapse of roof structure)

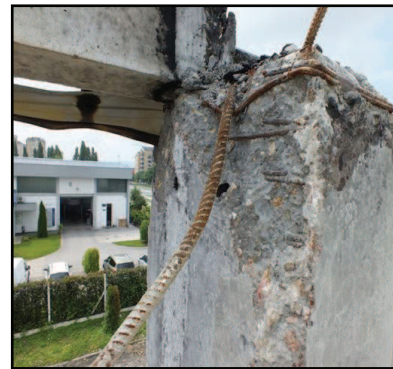
Figure 6: Crumbling of concrete in the supporting zone, peeling of surface and protective concrete layers, deformed stirrups and anchors, change in aggregate colour

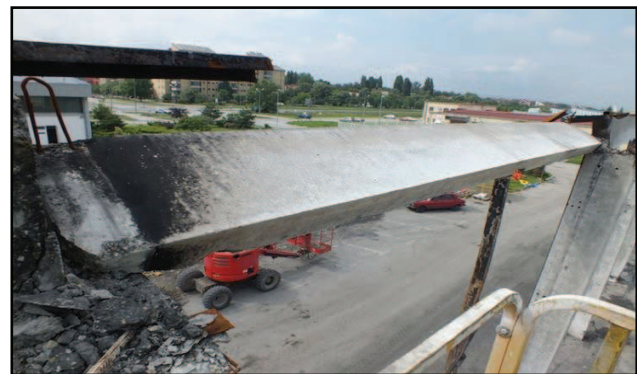
Figure 7: Beam rotation (tends to decline)

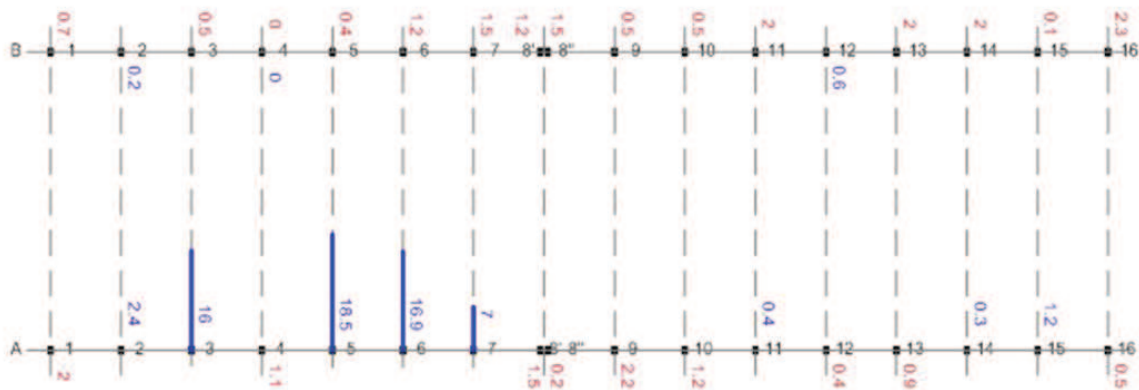
Figure 8: Schematic display of movement of the top of the column in relation to vertical axis

Columns A3, A5, A6 and A7 are evidently inclined towards the interior of the hall. Deviations of top parts of these columns in relation to fixed part of the column, i.e. in relation to the axis of non-deformed column, are great and are between 71-185 mm. Most of the columns were not deformed, nor was there excess of tension due to bending, because the main roof carrier fell from their supports relatively fast. However, on columns A3, A5, A6 and A7 connection between anchors on the top of the column and main roof carriers broke only after columns started to bend.
