# THE ASSESSMENT AND REPAIR OF THE PRECAST RC STRUCTURE EXPOSED TO FIRE

*This paper presents the assessment and repair of precast RC structure exposed to fire in Novi Sad. Detailed visual inspection, which includes described and classified damages and defects of RC columns and beams, is presented in the paper. Control design of the built-in concrete and reinforcement, as well as geodetic survey and conclusion on the state of the structure, are carried out. Two possible repair solutions were analysed.*

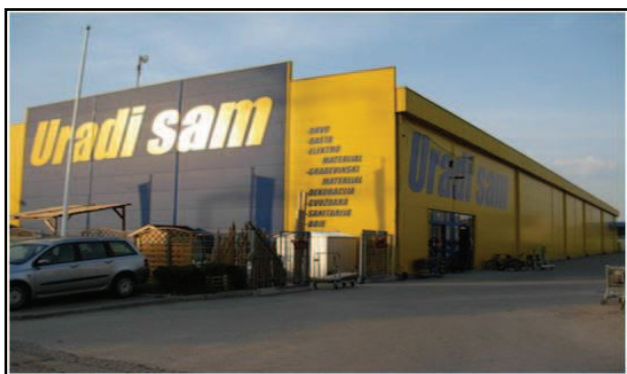
On May 5<sup>th</sup> 2013. there was a fire in production hall-building "Uradi sam" in Novi Sad. Major interior parts with installations, roof coverings and facade's cladding, as well as complete roof-bearing structure have been destroyed during the fire. RC columns and RC facade beams have suffered serious damages. Object's appearance before and after fire and clearing the ground off, are presented in Figures 1 and 2.

Figure 1: Object's appearance before fire
