# MECHANICAL AND MICROSTRUCTURAL BEHAVIOR OF COLLOIDAL NANO-SILICA MODIFIED PUMICE LIGHTWEIGHT CONCRETE UNDER FREEZE–THAW CYCLES

Serdar Yildirim\*

Kafkas University, Sarıkamış Vocational School, Department of Land Registry and Cadastre, Kars, Türkiye

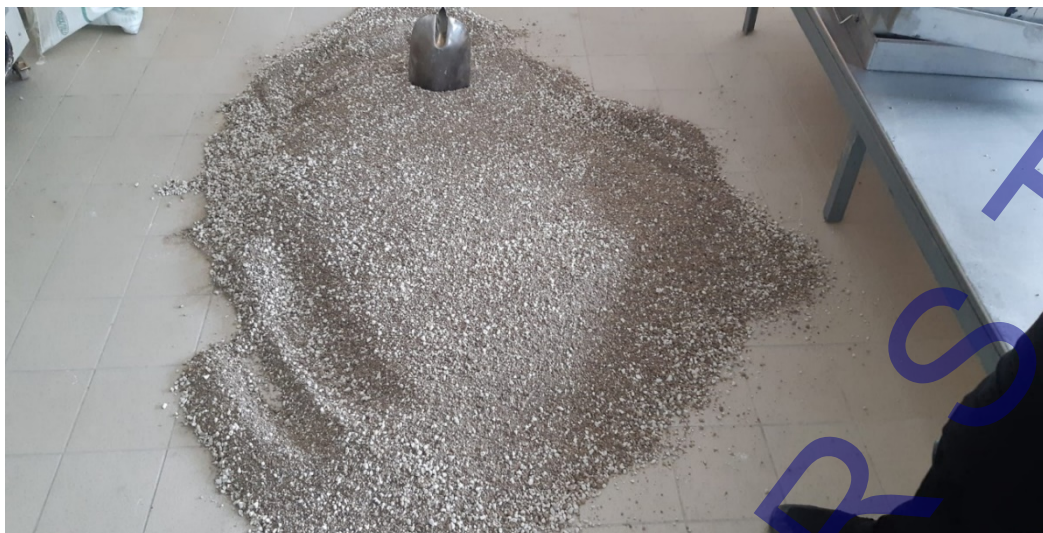
Fig. 1. Sarıkamış (Türkiye) pumice aggregate used in the study

In this study, CEM I 42.5 R Portland cement conforming to TS EN 197-1 [18] was used as the binder material. Potable water complying with TS EN 1008 [19] was used as mixing water. Pumice aggregate obtained from the Sarıkamış region of Türkiye was used as lightweight aggregate. The maximum aggregate particle size was 8 mm. An image of the Sarıkamış (Türkiye) pumice aggregate used in the study is presented in Fig. 1.

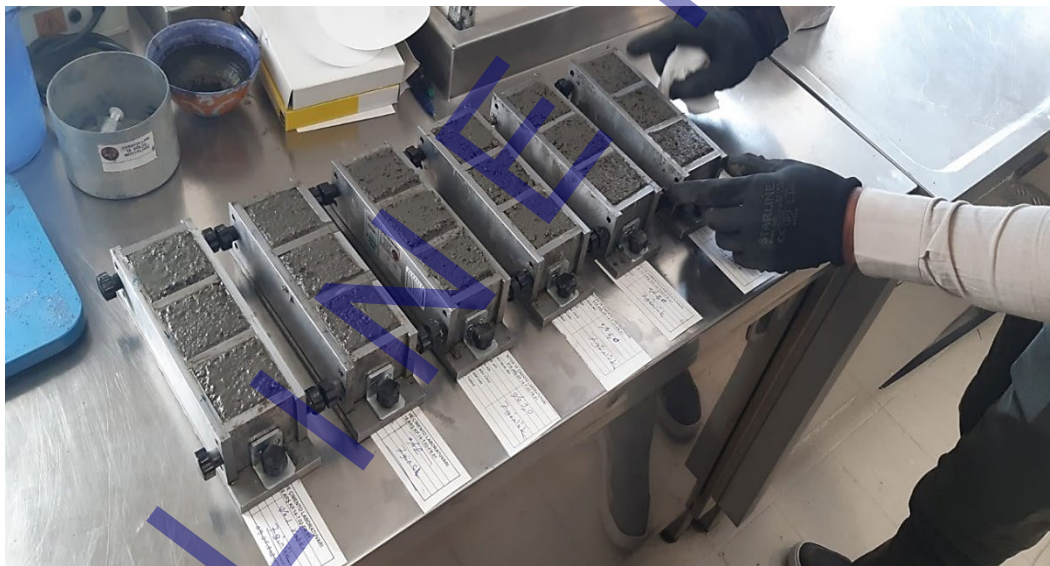
Fig. 2. Preparation of concrete specimens and placement into steel molds

Concrete mixtures were prepared using a laboratory-type mechanical mixer. Fresh concrete mixtures were cast into  $50 \times 50 \times 50$  mm steel cube molds. Since the maximum aggregate particle size was 8 mm, the selected specimen dimensions were considered sufficient to provide an appropriate aggregate/specimen ratio. The specimens were compacted in accordance with TS EN 12390-2 [20]. After demolding, the specimens were cured in water at  $20 \pm 2$  °C following the initial 24 h period.
